RECOVERY OF BURIED
INDUSTRIAL WASTES
AND
AQUIFER REHABILITATION
AND
MONITORING AT OLIPHANT,
BRUCE COUNTY

RECOVERY OF BURIED INDUSTRIAL
WASTES AND
AQUIFER REHABILITATION AND
MONITORING AT OLIPHANT,
BRUCE COUNTY

Prepared
by
B. Novakovic

Southwestern Region
Technical Support Section
Water Resources Assessment Unit
London
March, 1984

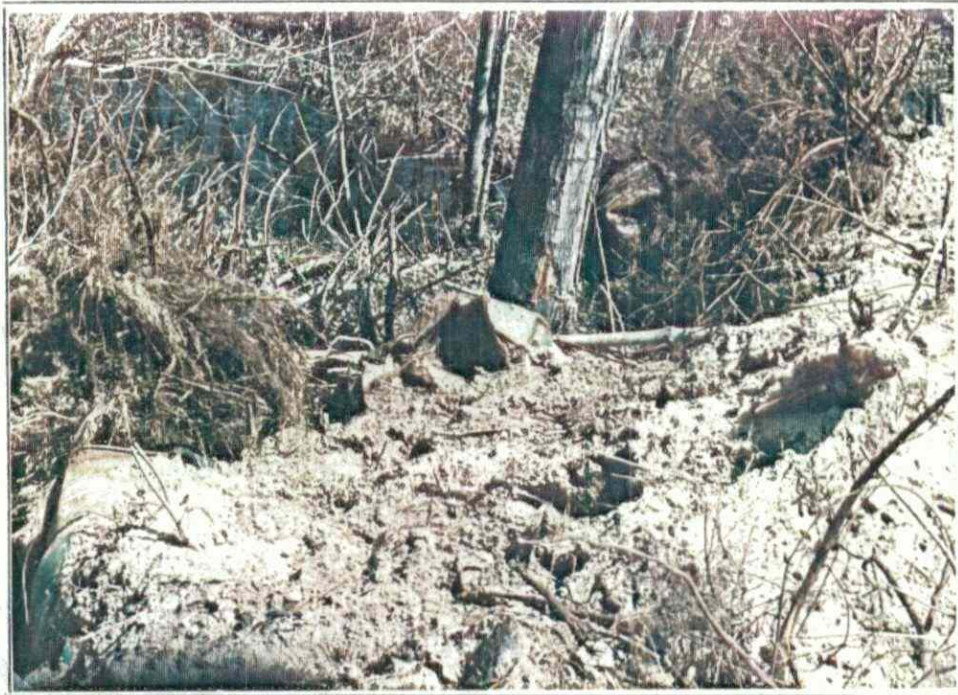
Photo 2. Looking east at the eastern edge of the sand pit, two green drums are partially covered with sand. The third drum is partially behind the tree (centre). These drums had been dug up during the spring of 1983 and dumped in this area.
(Photo taken on May 4, 1983 by Jim McRorie)

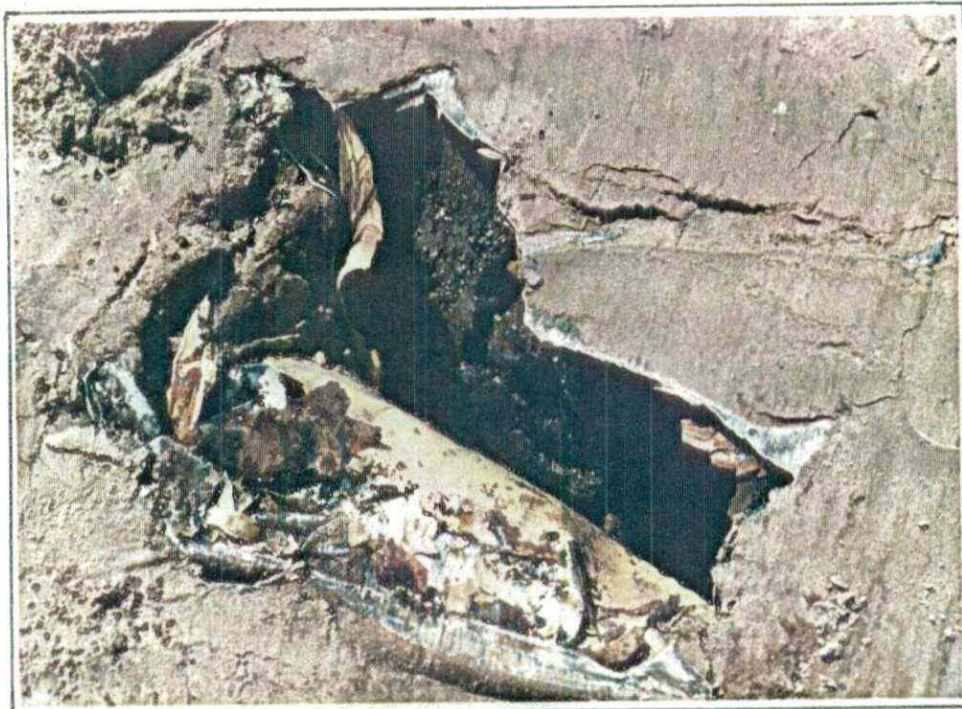
Photo 3. A close up of the drum uncovered beneath 15 cm of sand from the floor of the sand pit approximately 15 m southwest of the garage. The drum was ripped open by the front-end loader during the removal of sand cover. The orange and black solid metallic waste contained in the drum was revealed.
(Photo taken on May 4, 1983 by Jim McRorie)

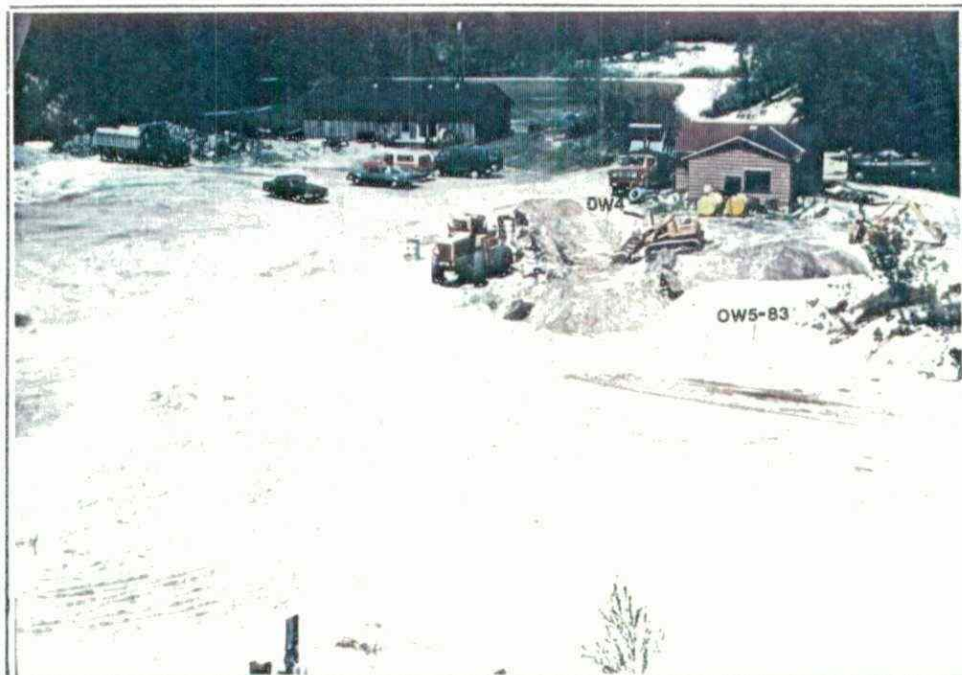
Photo 4. Looking north, the commencement of the cleanup operation is shown. The first drum which contained liquid industrial waste is to the left of the rubber-tired front end-loader.
(Photo taken on June 16, 1983)

The initial clean-up was carried out in Area 1 (Figure 2, Photo 4) from which 170, 45 gallon drums containing metallic grinding dust and 15 drums containing liquid waste were removed. In addition to the drums, loose waste materials were also encountered and removed (Photo 6). Most of the drums were buried just above the water table (1.4 m) and the entire original liquid portion of the drums containing metallic dust had leaked into the subsurface thus contaminating sand and groundwater beneath them (Photo 7).

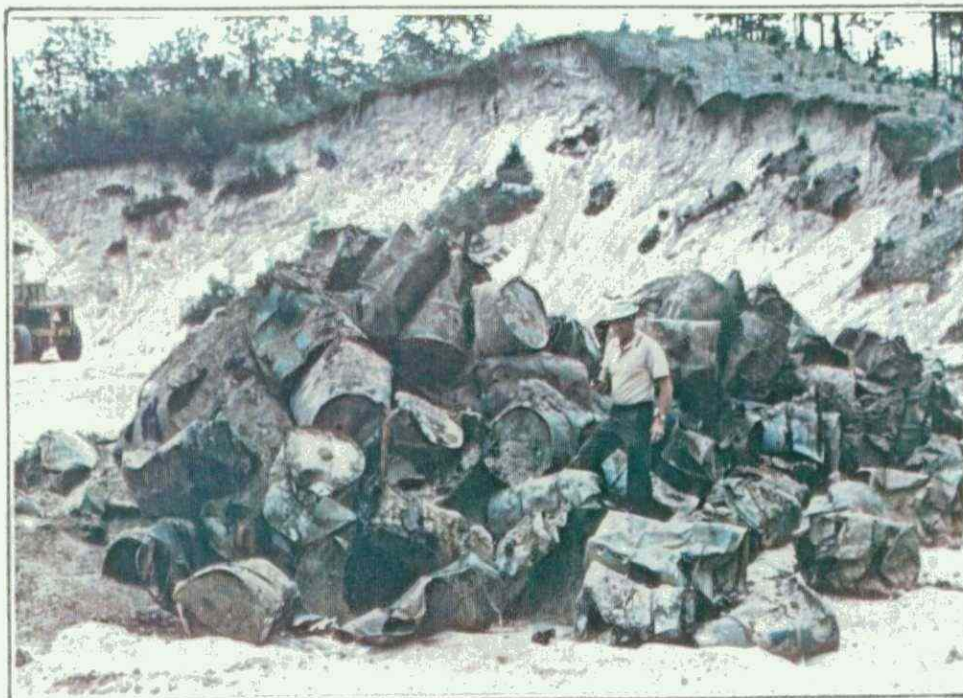
Photo 5. Drums containing solid metallic grindings and liquid industrial wastes were piled up at the southern edge of the pit. Drums containing liquid waste had been removed before this photo was taken.
(Photo taken on June 23, 1983)

During Phase I of the clean-up operation, drums containing solid waste were piled up in a separate pile from those containing liquid waste. Both piles were located at the southern working face of the Field sand pit (Photo 5). Polyethylene sheets were placed beneath the drums containing liquid waste in case any of them developed leakage.

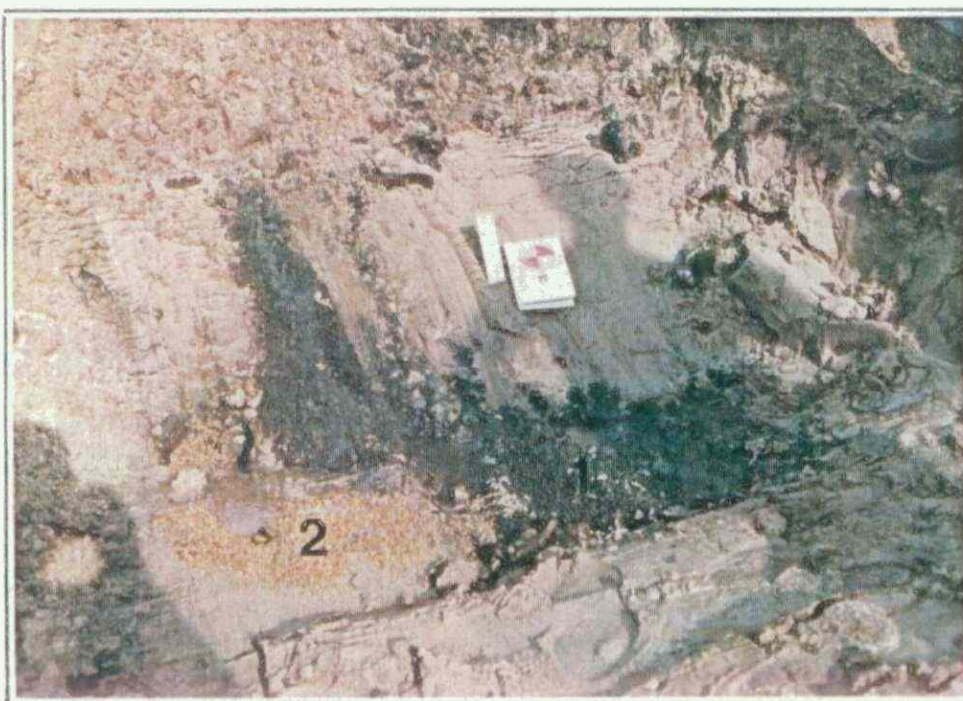
Photo 6. In addition to the drums, loose waste materials were also encountered in the excavation. The grey/black material (1) appeared to be metal grindings while the orange coloured material (2) was identified by the staff of the originator of some of the waste as the media from a tumbler or polisher.
(Photo taken on June 17, 1983 by Jim McRorie)

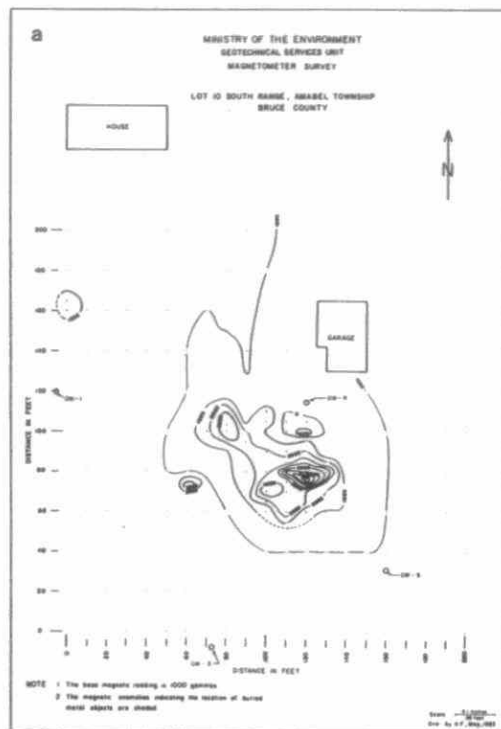
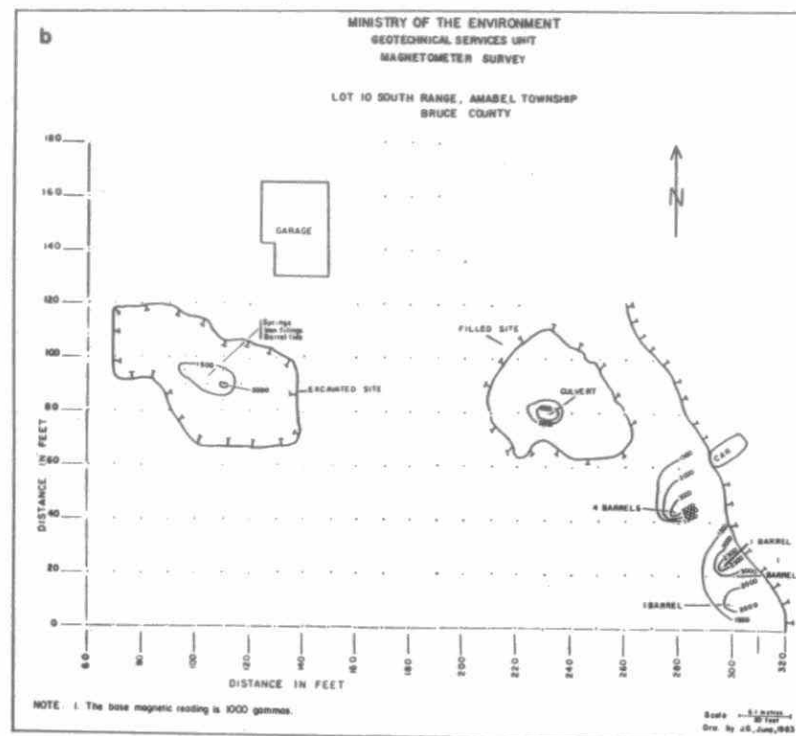
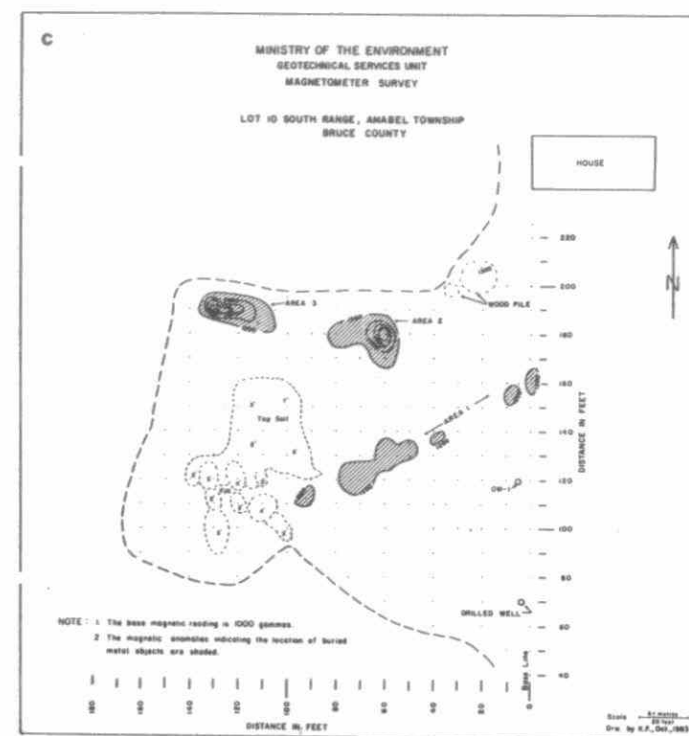
Figure 8. Geophysical survey maps.

(Figure 8). The survey was carried out by staff of the Geotechnical Services, Water Resources Branch of the MOE. A distinctive magnetic anomaly clearly delineated the location of the drummed wastes. Three favourable factors contributed to this success: (a) metallic contents of the drums, (b) the drums themselves were made of metal, and (c) the shallow burial of drums and waste.

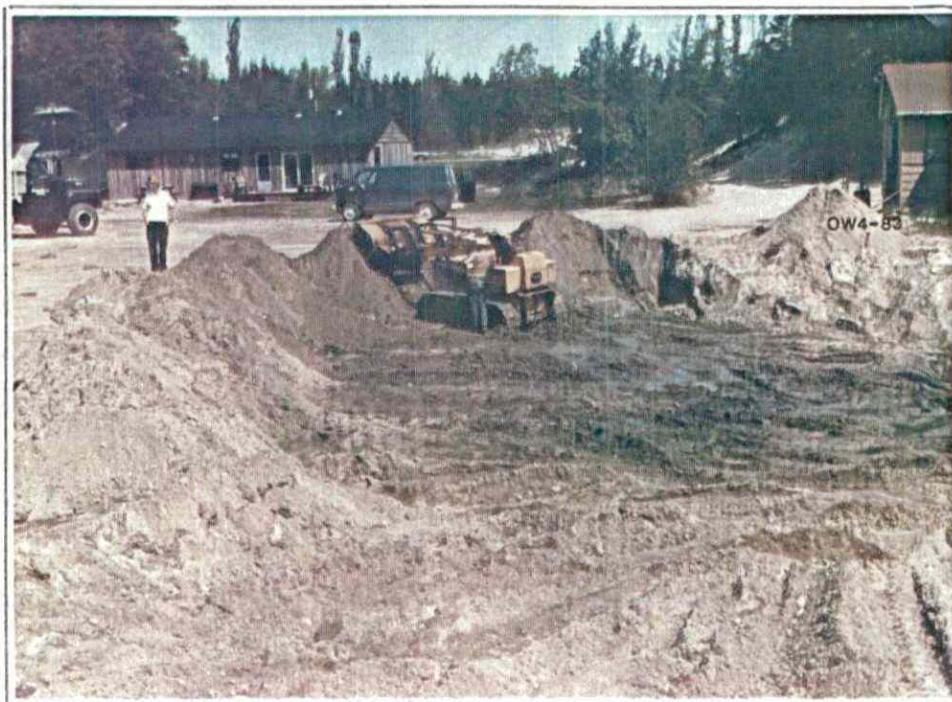
Photo 7. Looking north, a portion of the bottom of the excavation is shown, after the drums and loose waste has been removed. The water table is immediately beneath the floor of the excavation. (Photo taken on June 17, 1983 by Jim McRorie)

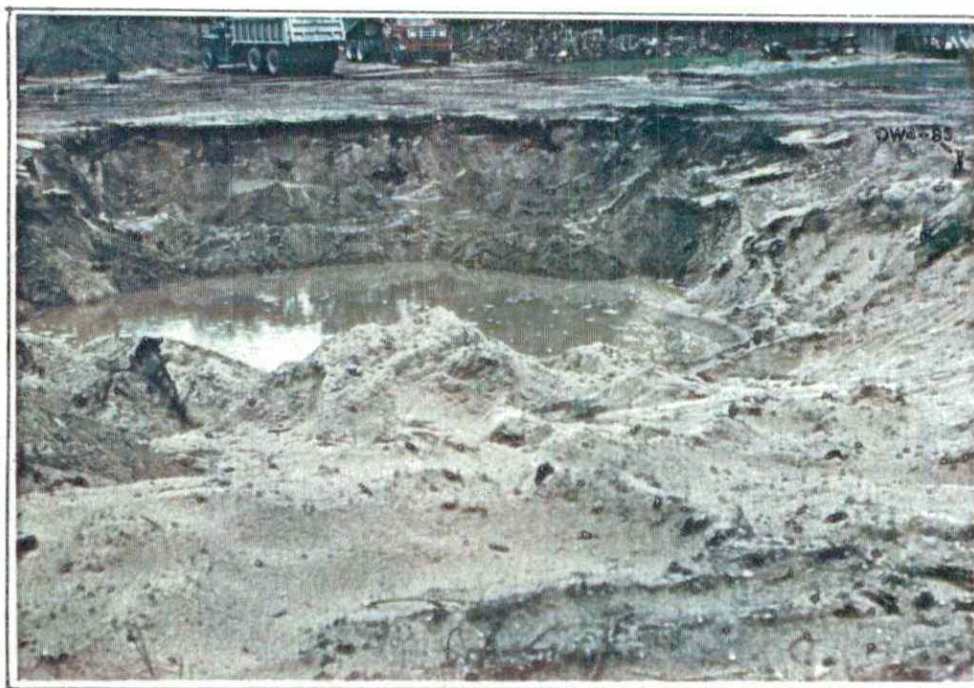
Photo 8. Looking north a portion of the temporary pond created by the removal of contaminated sand from beneath the drums is shown. (Photo taken on June 23, 1983)

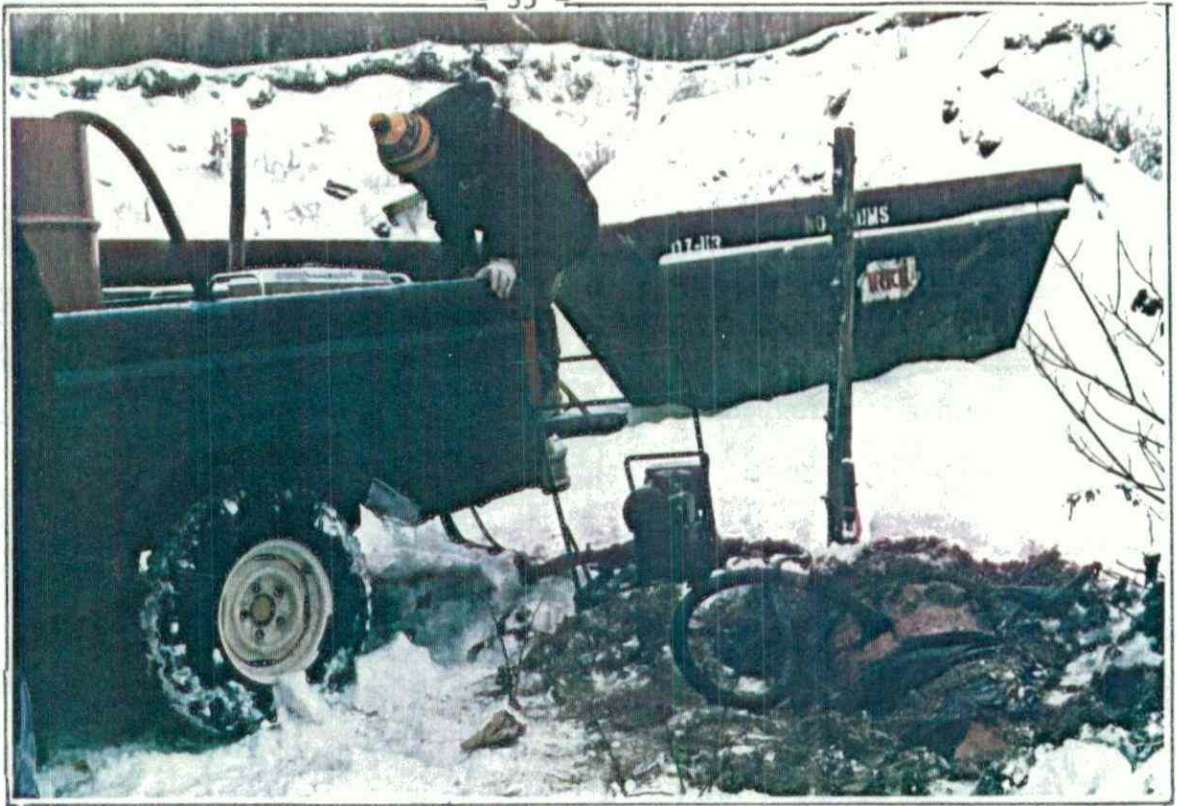
In Area 4 two drums (pink and green) containing liquid waste (paint solvent) were recovered. Portions of the contents of the green coloured drum had already leaked into the subsurface. The drum content was transferred into sound drums and taken from the site on the same day by the originator of some of the waste (Photo 9).

Photo 9. Liquid waste from the pink drum being transferred to a sound drum brought in for this purposes by the generator of some of the waste.
(Photo taken on December 7, 1983)

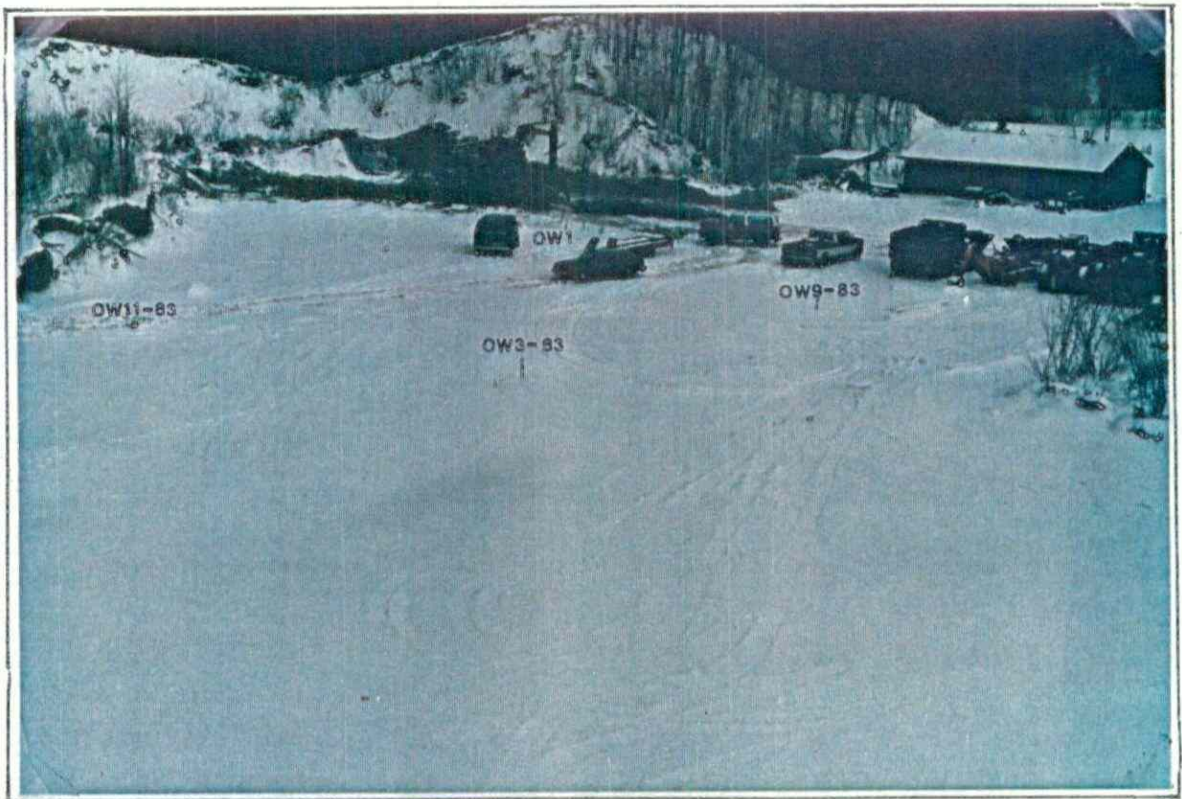
Photo 10. Looking northwest, the completed cleanup areas 3, 4 and 5 are in the northwestern section of the Field sand pit. The absence of snow delineates the extent of the clean up.
(Photo taken on December 8, 1983)

Because additional lugger buckets were not available at the site, the contaminated sand and some loose waste mainly from excavation area 5 were initially stockpiled immediately southwest of Area 4 (Photo 10). By December 19, 1983 all excavated sand, waste, and drums were taken from the pit by Tricil Waste Management Limited for disposal at their site near Sarnia. This amounted to the total of 86 m³.

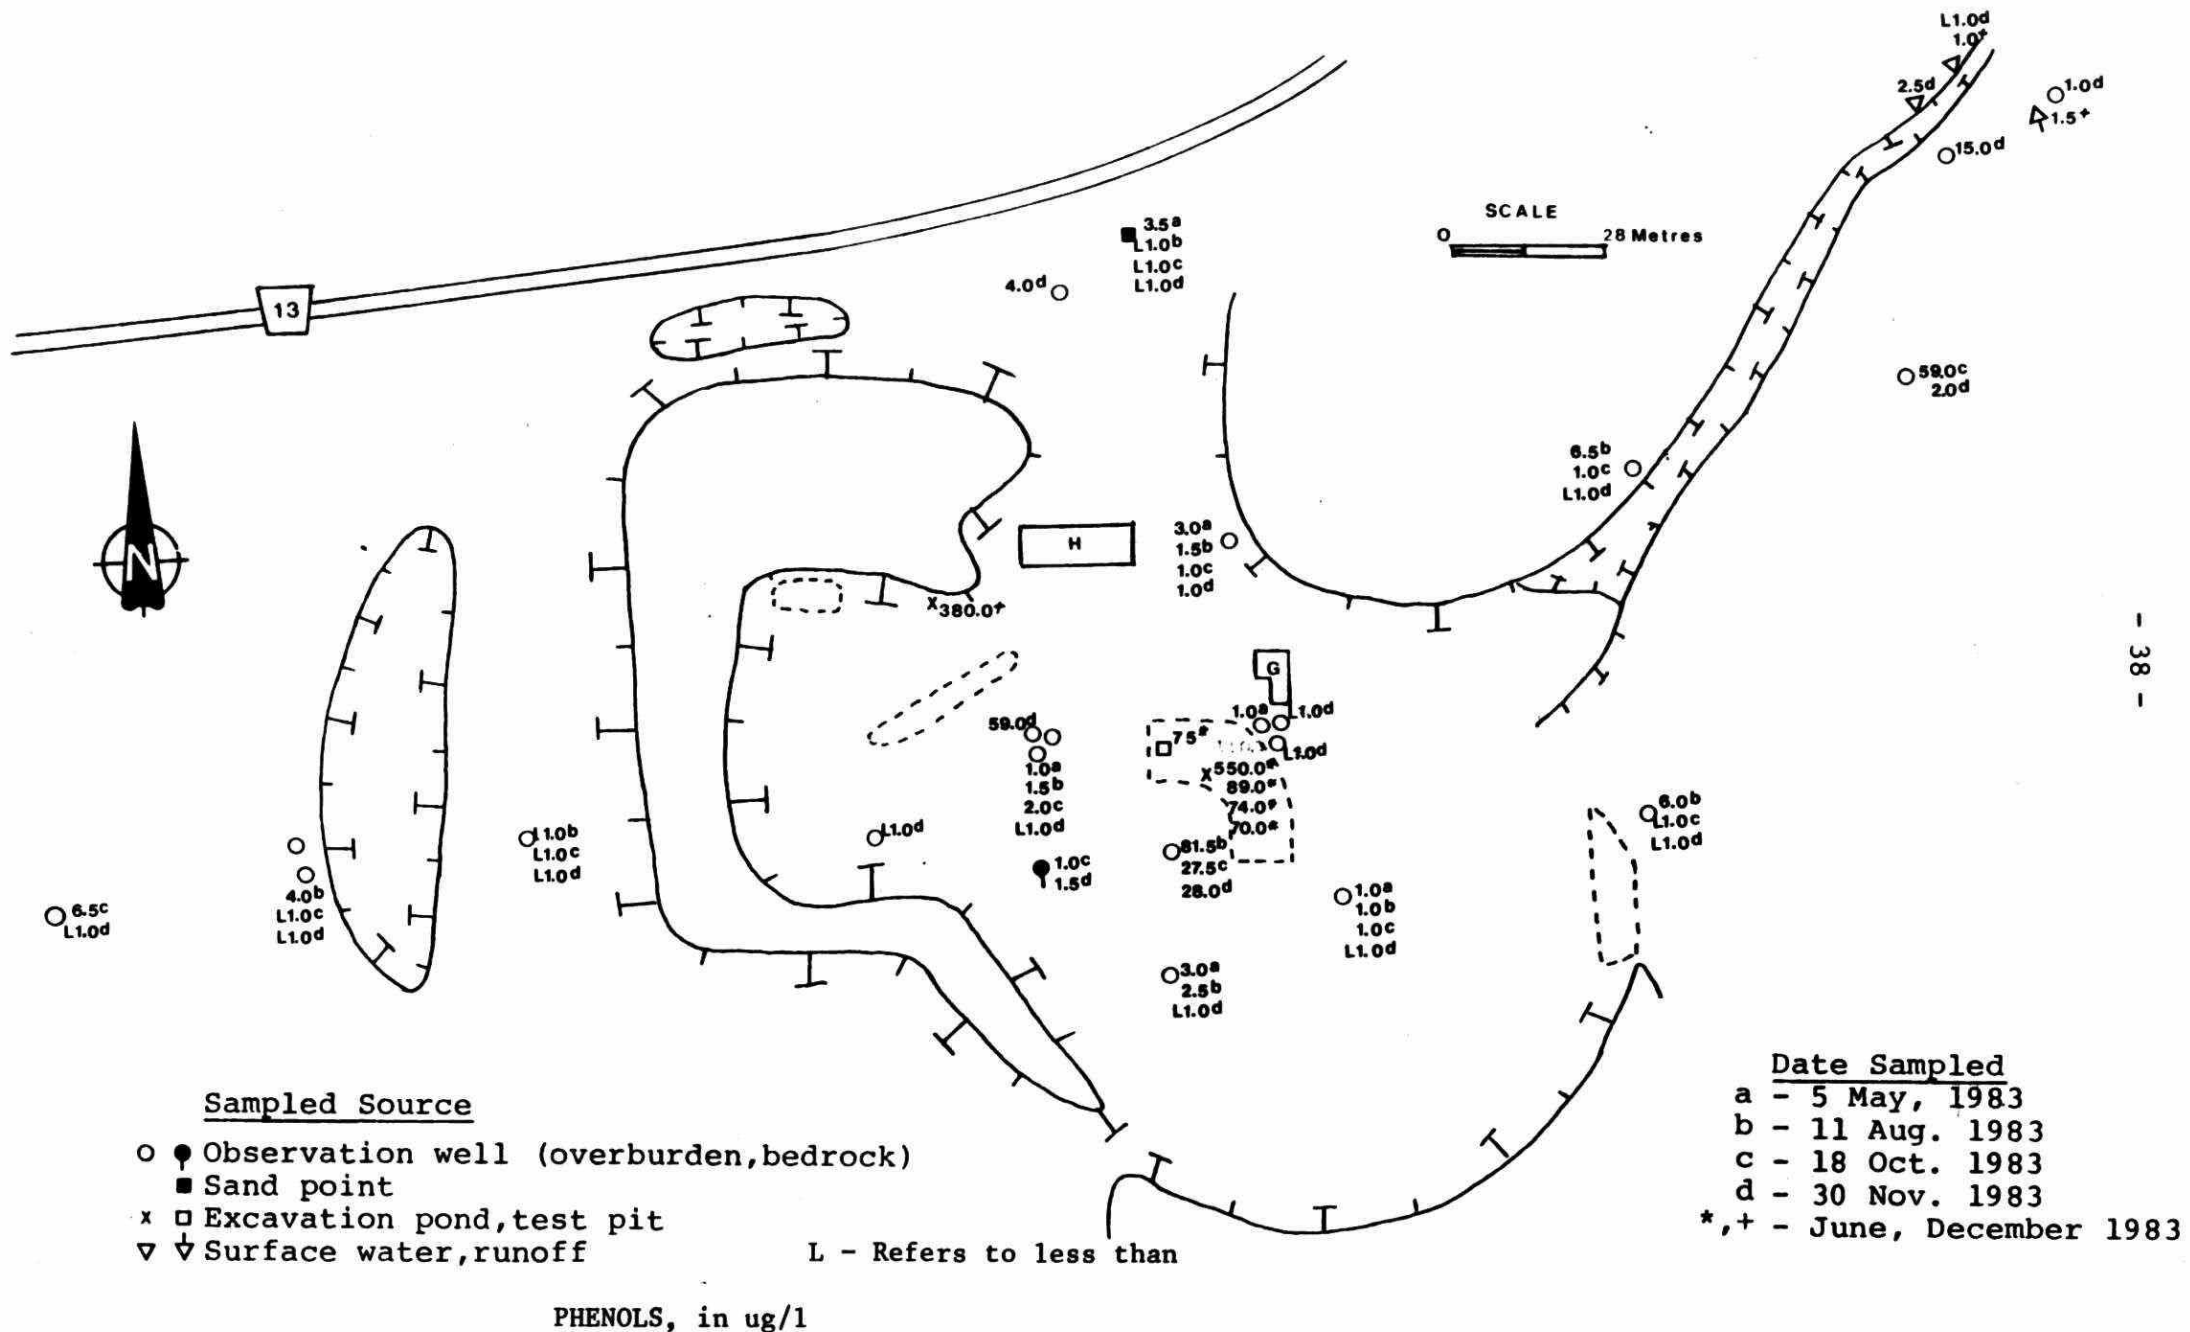
Figure 9. Hydrochemical map of phenolic compounds distribution in groundwater and surface water systems.

Relatively high phenols and dissolved organic carbon contents were found in the initial samples in both ponds (excavation area 1: phenols 550 ug/L, DOC 173 mg/L, excavation area 4: phenols 380 ug/L, DOC 59 mg/L). These phenol levels far exceed the Ontario Drinking Water Objective of 2 ug/L.
